# COMMERCIAL STRUCTURE INVESTIGATIONS

A number of structural system investigations shown in the galleries below are of buildings framed using concrete. Damage to the concrete frame and slab system may be the result of a corrosive interior or exterior environment, poor workmanship, previous remodeling projects or structural failure.

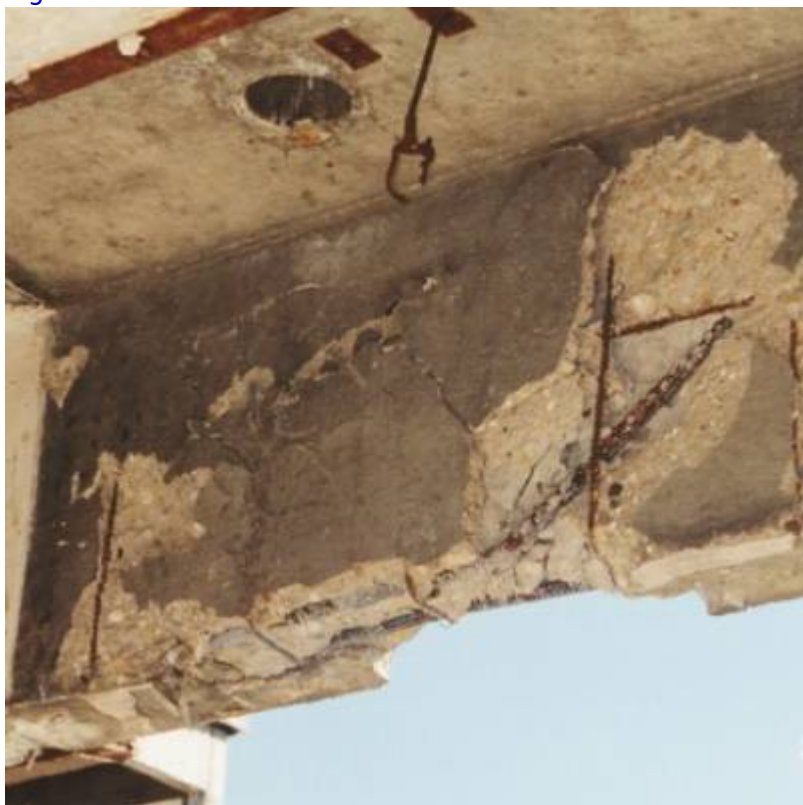
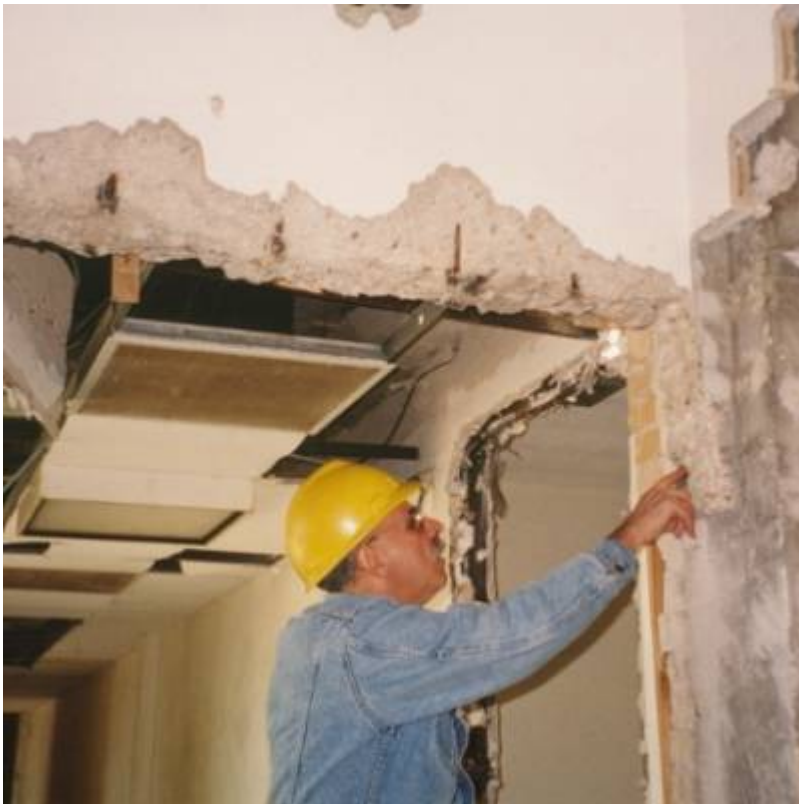
Damage to the concrete frame as a result of deterioration, previous remodeling projects or accidents during demolition may occur. Restoration of these elements helps ensure the continued "health" of the structure (Figures 6 and 7).
