# COMMERCIAL STRUCTURE INVESTIGATIONS

A number of structural system investigations shown in the galleries below are of buildings framed using concrete. Damage to the concrete frame and slab system may be the result of a corrosive interior or exterior environment, poor workmanship, previous remodeling projects or structural failure.

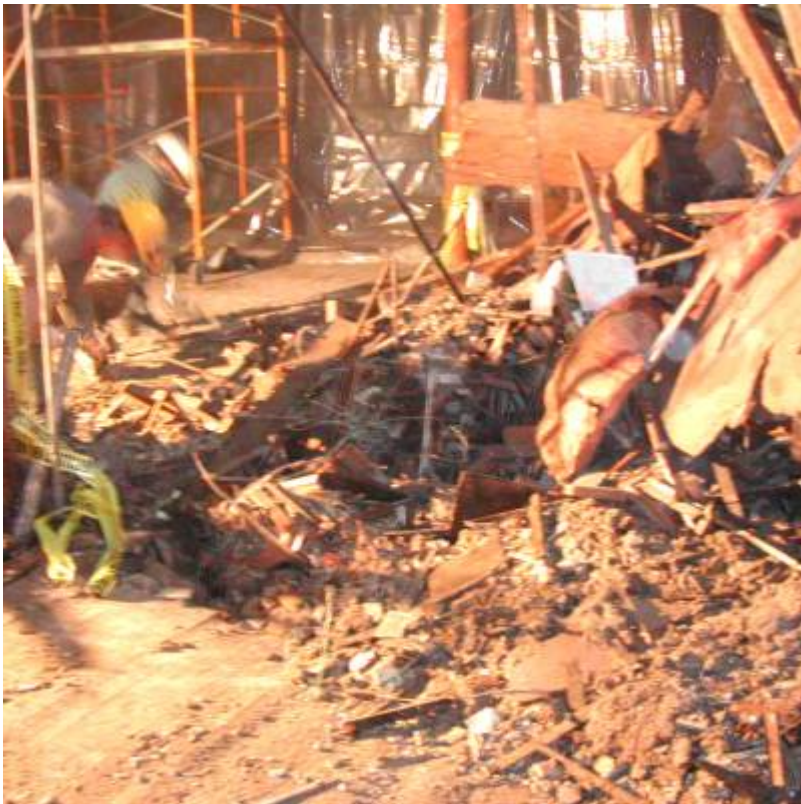
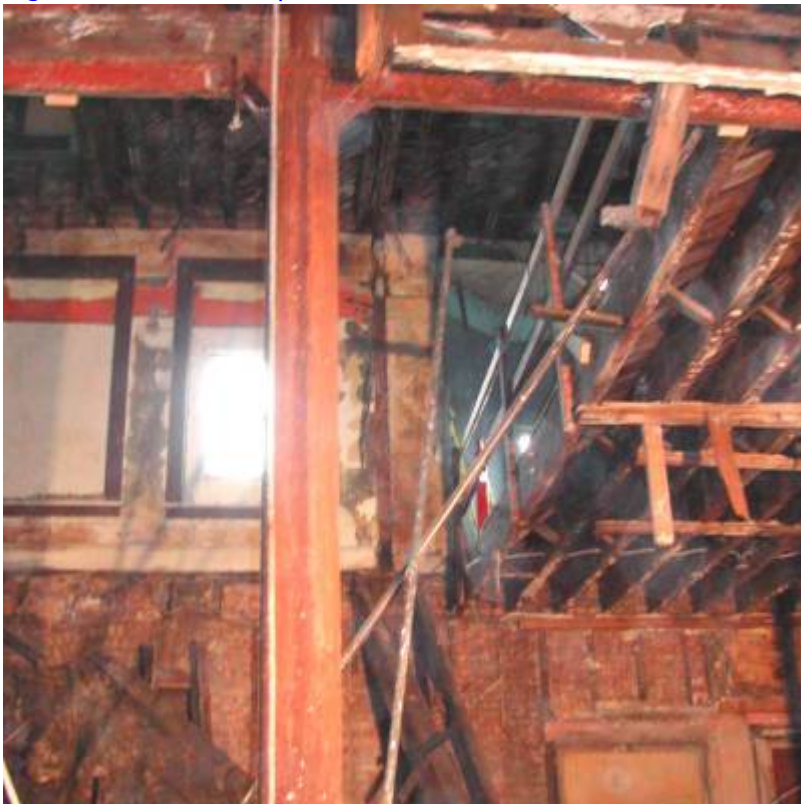
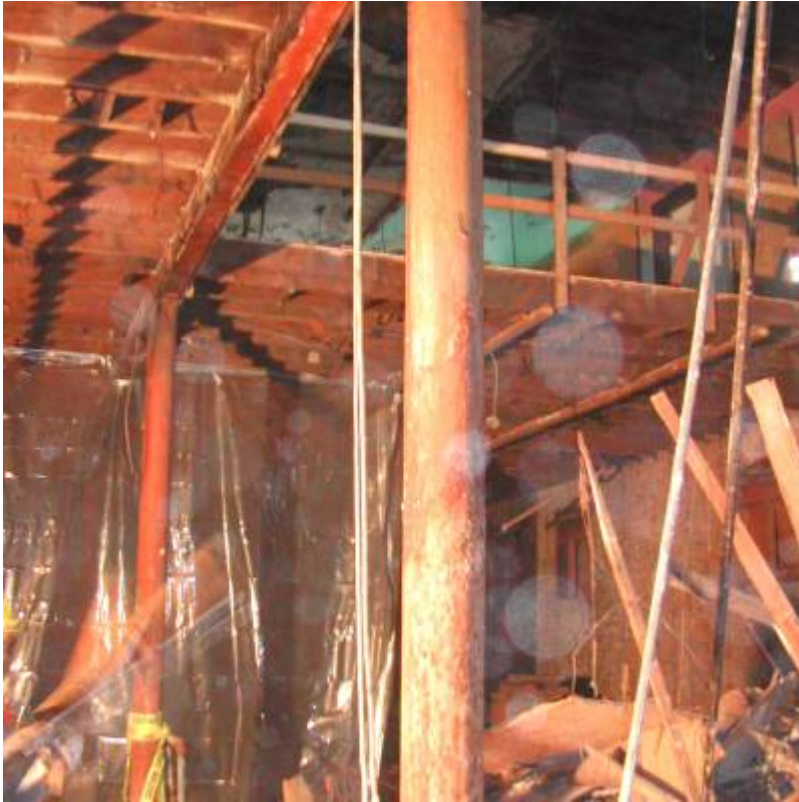
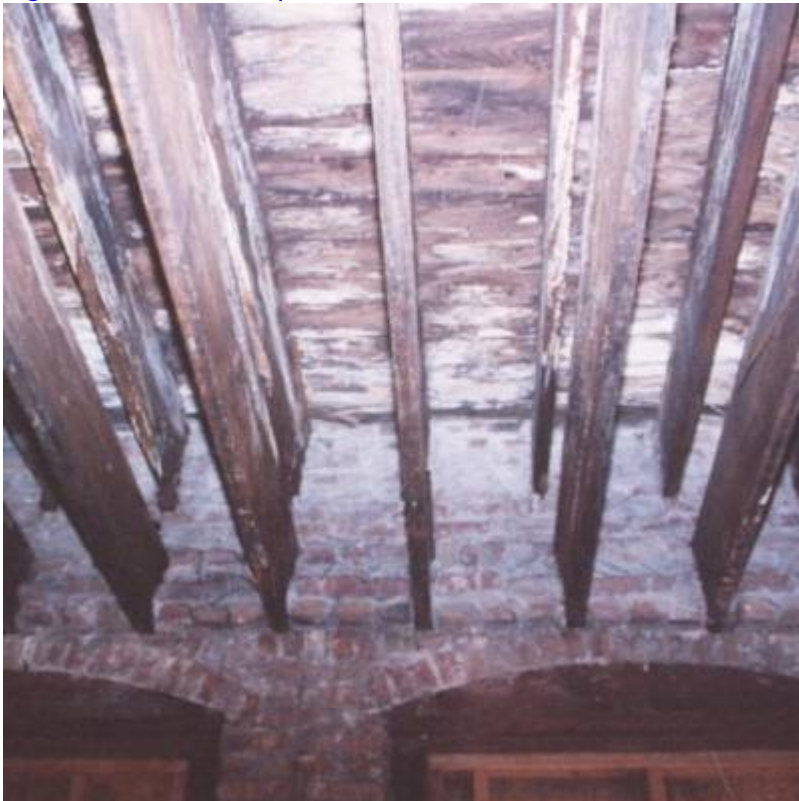
The renovation and rehabilitation of an apartment building one-hundred or more years old may involve dealing with posts made of cast iron, early iron or steel beams made of an unknown steel strength, timber without a grading stamp and most often no plans. The challenges can be numerous.

During the renovation process existing structural systems need careful evaluation for new loading conditions and for compliance with current building codes. Material properties may need to be determined to ensure compatibility with restoration materials.

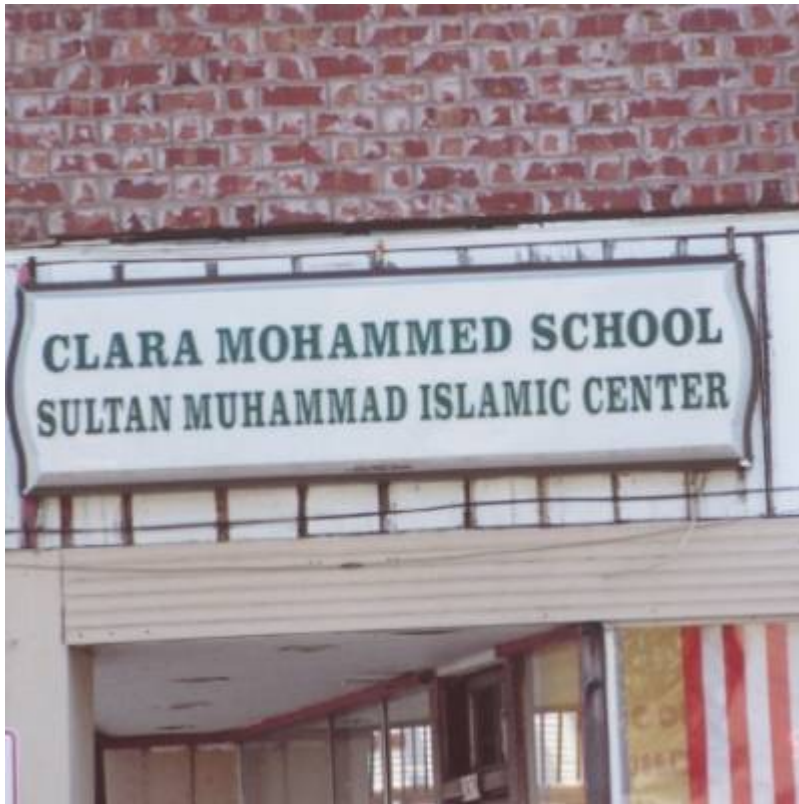
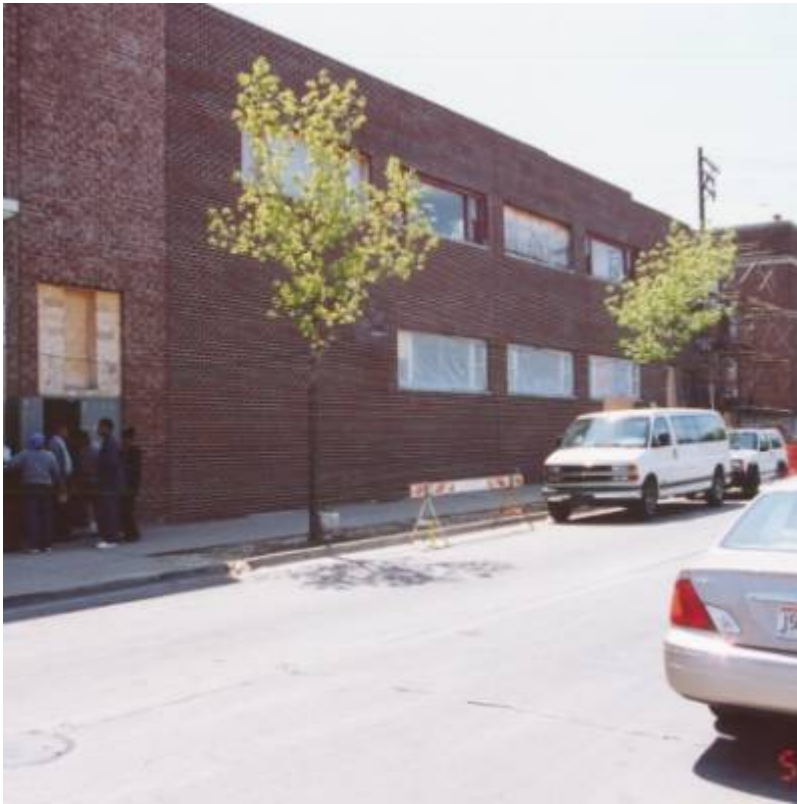
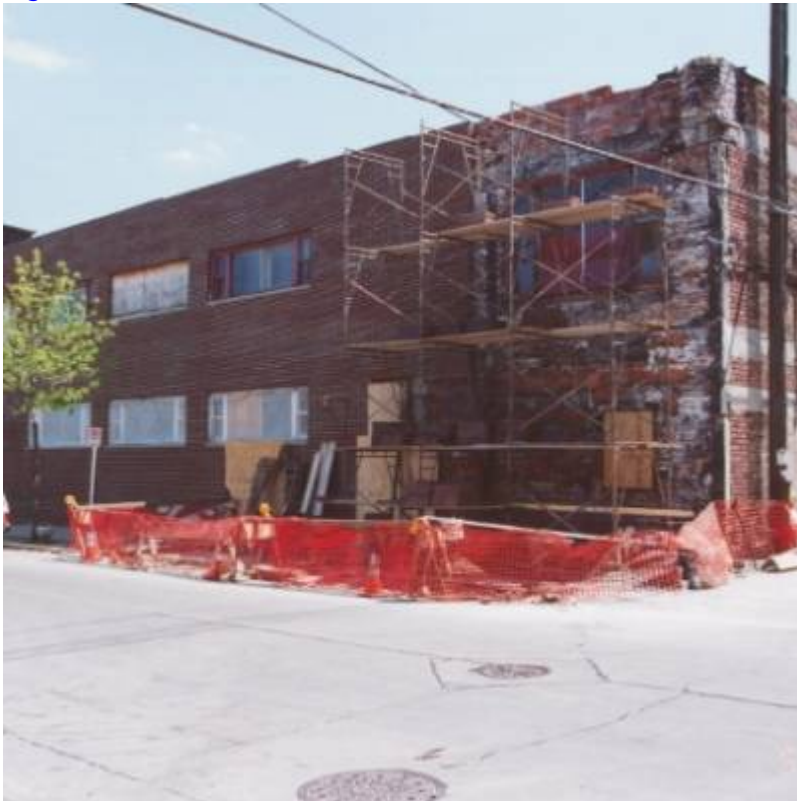
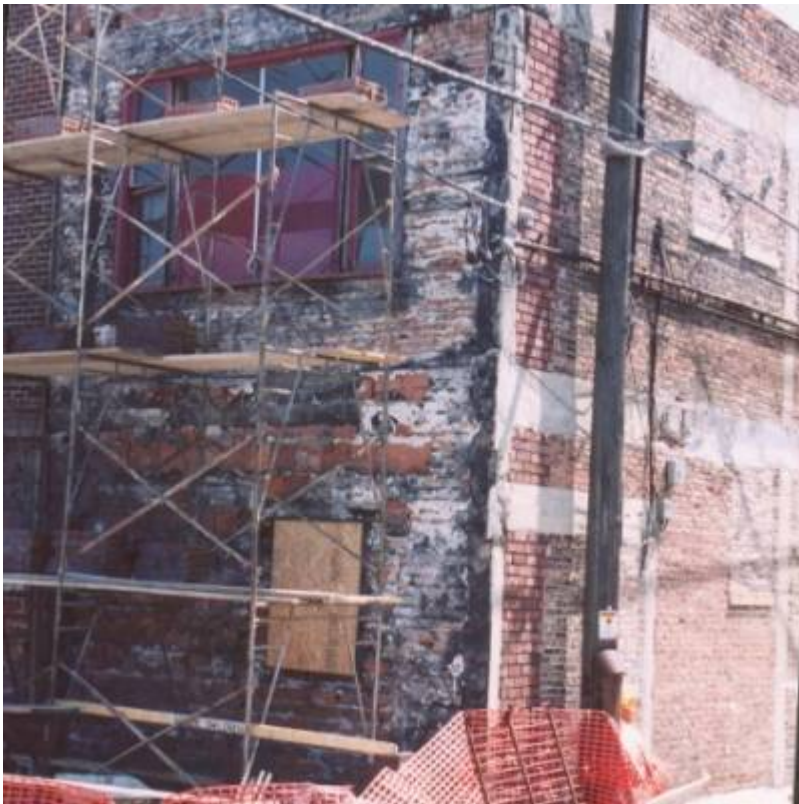
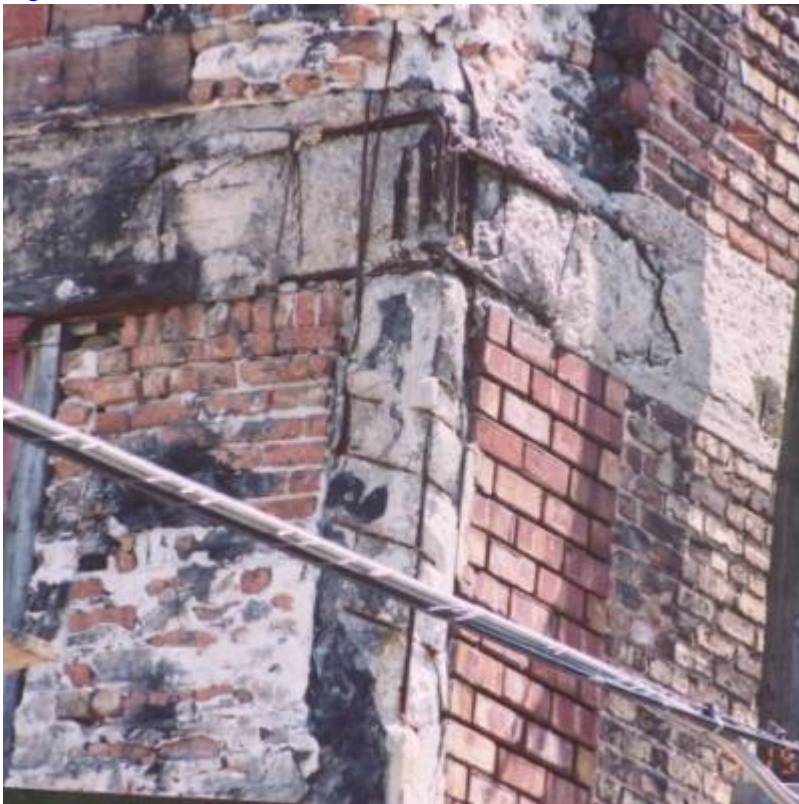
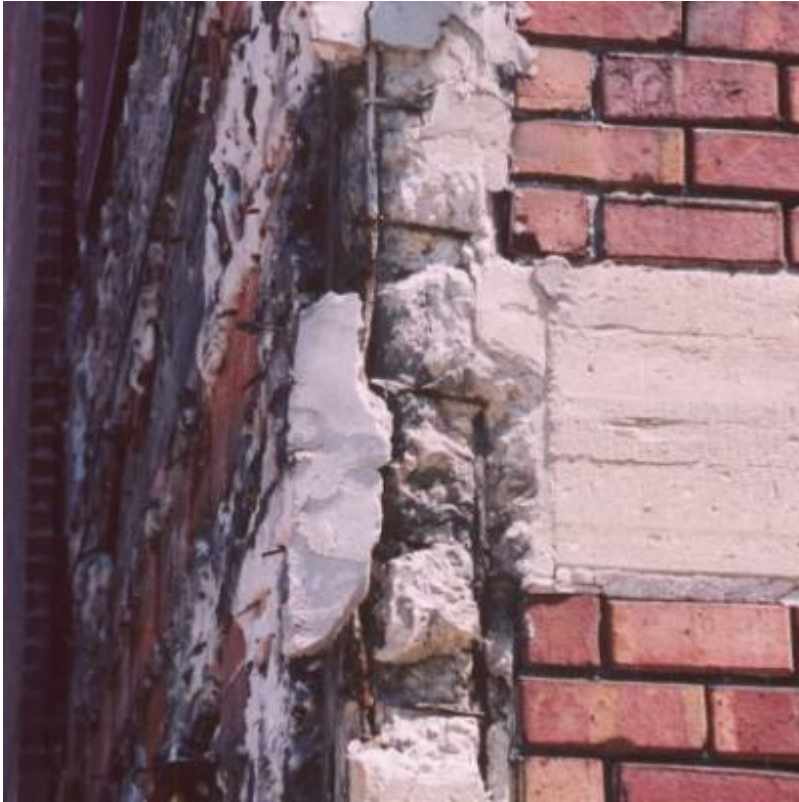
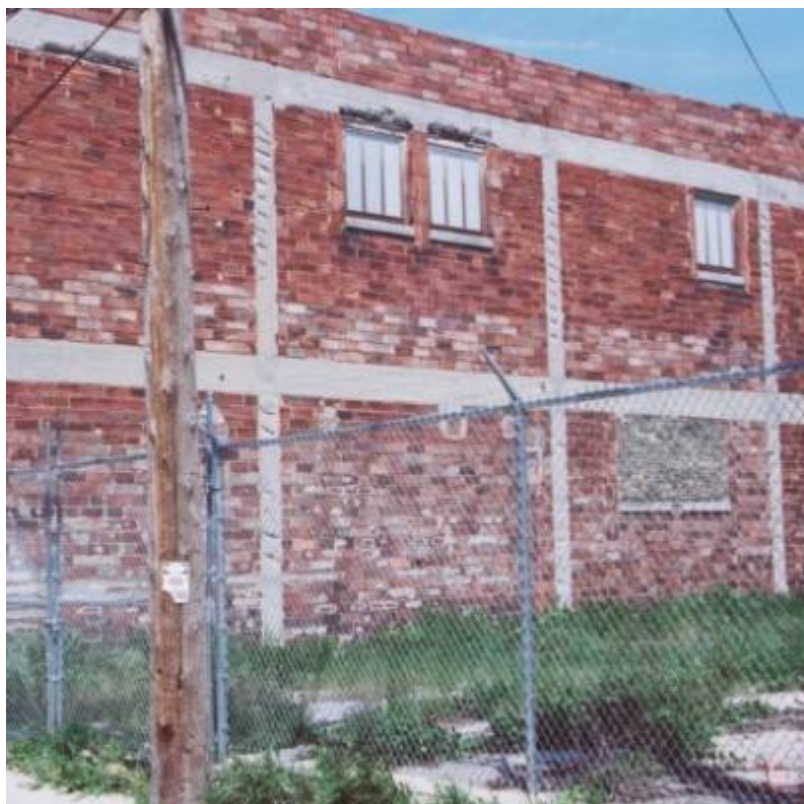
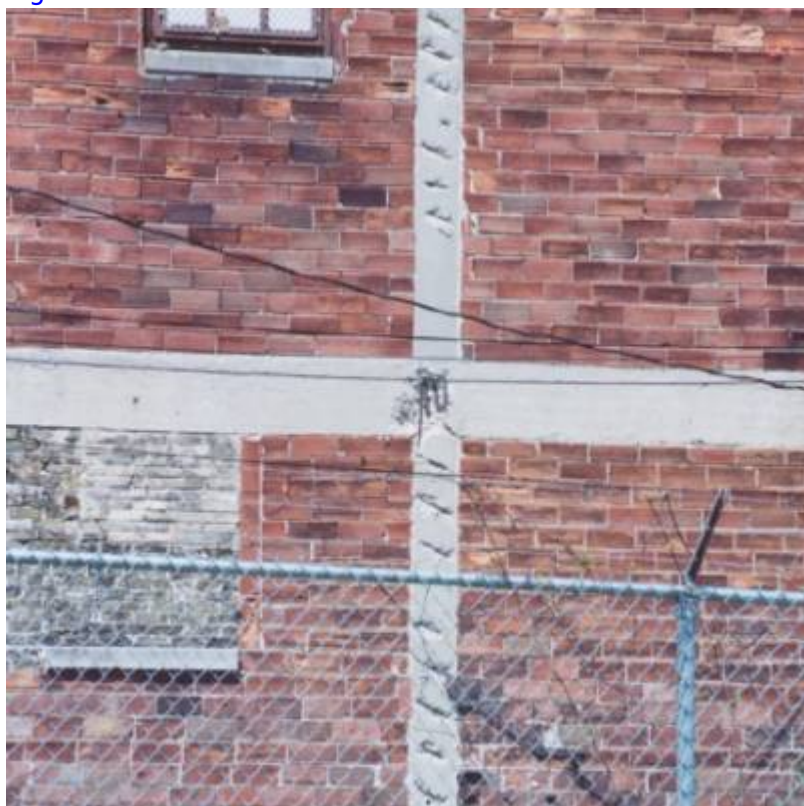
A one-hundred plus year-old former factory now used as a school has seen severe deterioration of its concrete frame over the years. Two sides of the structural frame have been totally exposed to the elements and the remaining two sides had a brick veneer over it. Corrosion of the reinforcement and subsequent cracking and delamination of the concrete was evident in numerous places. Water penetration through cracks and holes in the masonry and corrosion of reinforcement placed too close to the surface contributed to the deterioration.

Once a concrete frame has undergone such severe deterioration its strength can be greatly impaired. A program of investigation, documentation, field observations, testing, evaluation and reporting followed by rehabilitation becomes imperative. Several recommended repair details are shown below.

A program of restoration was recommended. It is important to maintain a building to keep structural deterioration in check.

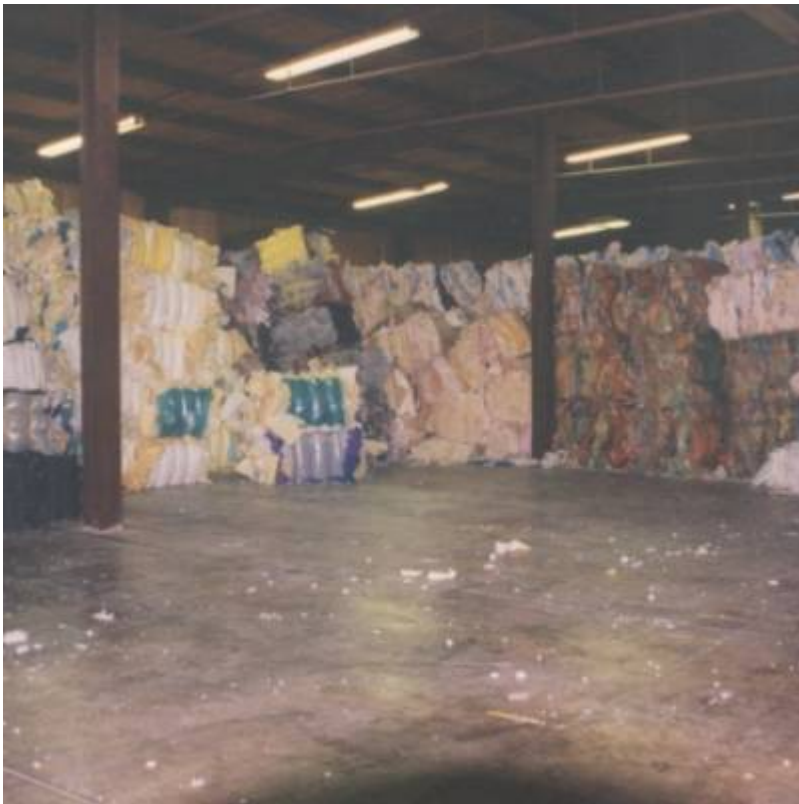
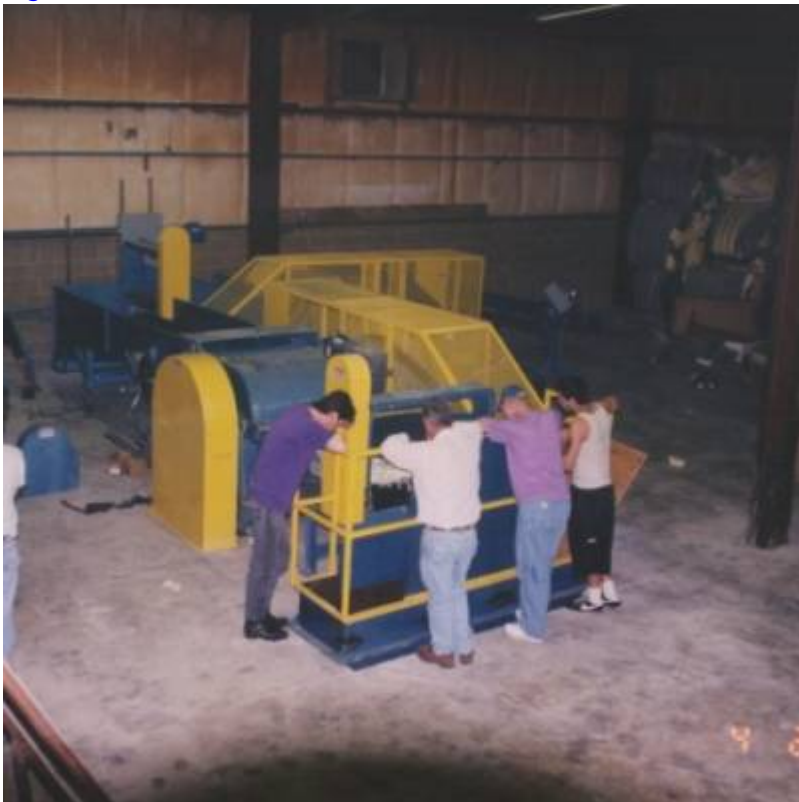
This industrial building's structural framing system was comprised of a pre-engineered steel frame and precast concrete floor slab. The owner, which recycles foam, wished to determine whether the second floor had any additional capacity for the companies operation. Well, not only did it not have any additional capacity, it's second floor beams were under-sized. As shown in Figure 4 stiffener plates were

added to these beams to bring their capacity up to the original prescribed design load of 100 psf.

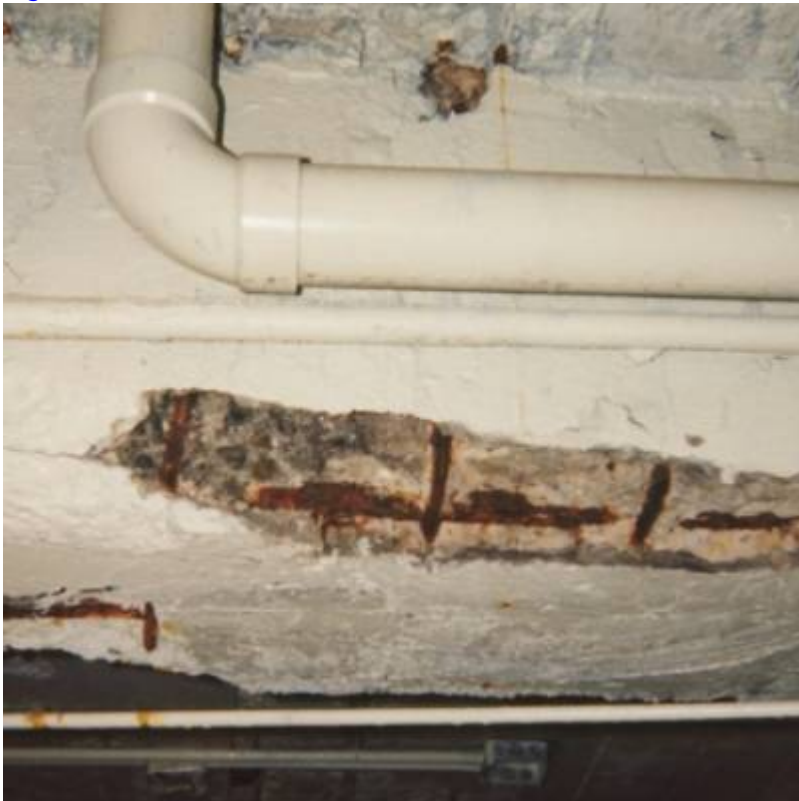
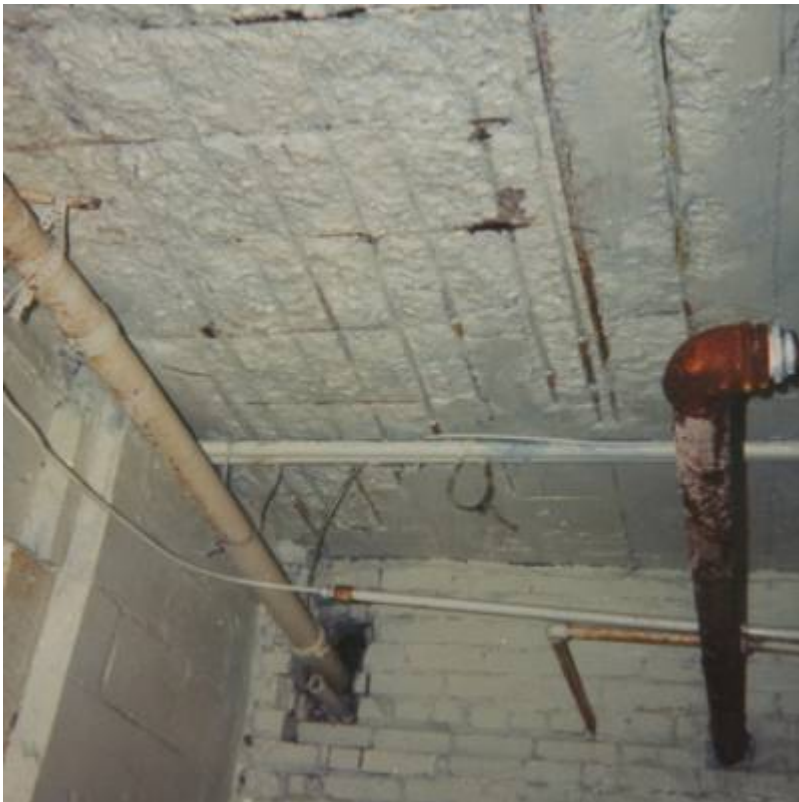
The first floor slab of this former dairy building showed extensive corrosion damage once all the insulation was removed from the ceiling below it. It was quite a shock to the new owners who wished to turn it into a brew pub. The solution for this project was to abandon the deteriorated floor slab, repair and

strengthen the floor beams and span between them with a concrete topped metal deck.

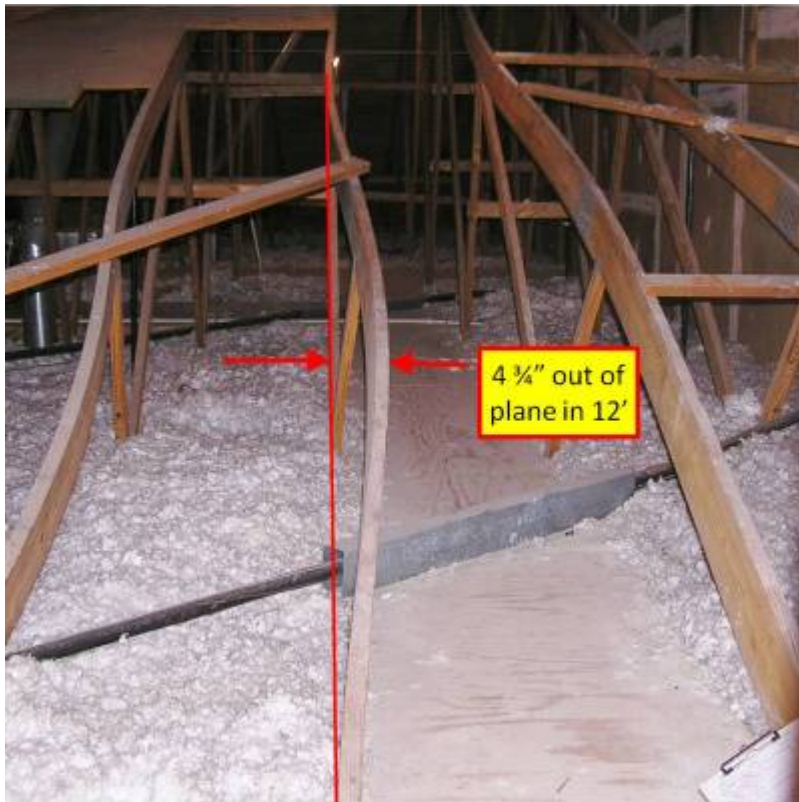
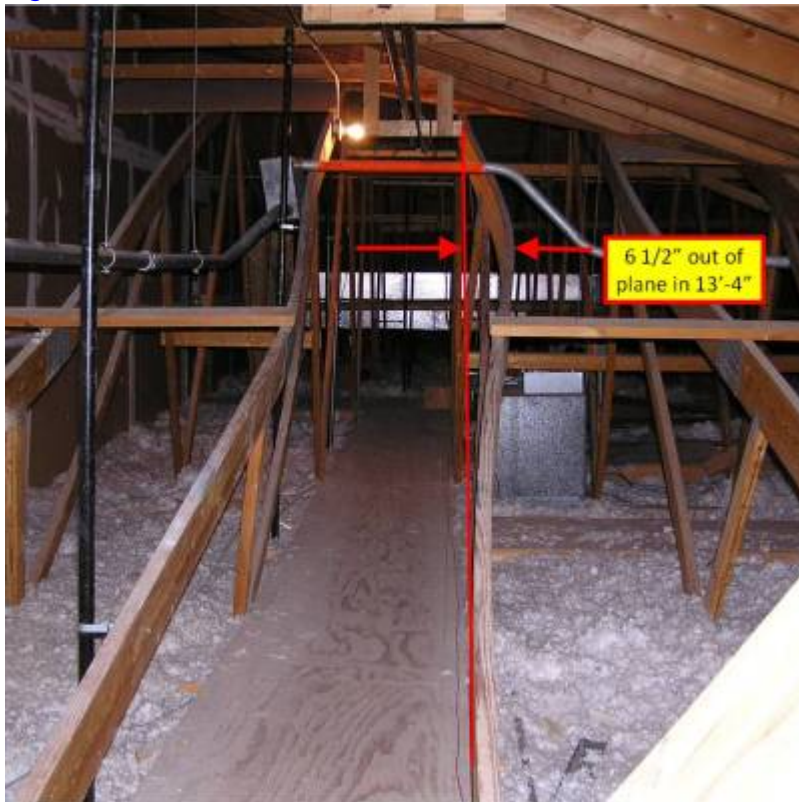
While investigating this strip mall's roof capacity for mechanical equipment added by a restaurant tenant an alarming discovery was made. It was discovered that errors made during construction by not providing the required permanent bracing in certain areas for the roof trusses caused them to deflect out-of-line. Over the years the top chords of these trusses, which should remain in a straight line had

deflected severely out-of-line.

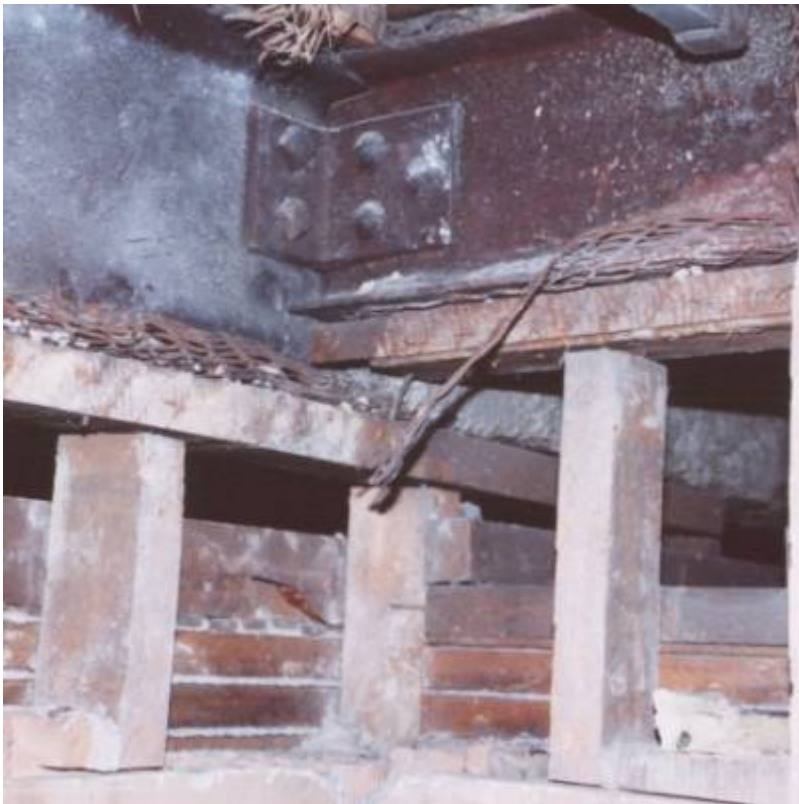
Fig. 4. Historic St. James Apartments.

The renovation and rehabilitation of an apartment building one-hundred or more years old may involve dealing with posts made of cast iron, early iron or steel columns and beams made of an unknown steel strength, concrete floor systems of unknown capacity and most often no plans. The challenges can be numerous. This project involved the review of existing steel framing which supported an elevator that owner wished to upgrade.

During the retrofit process existing structural systems needed careful evaluation for new loading conditions and for compliance with current building codes. Material properties may need to be determined to ensure compatibility with restoration materials.

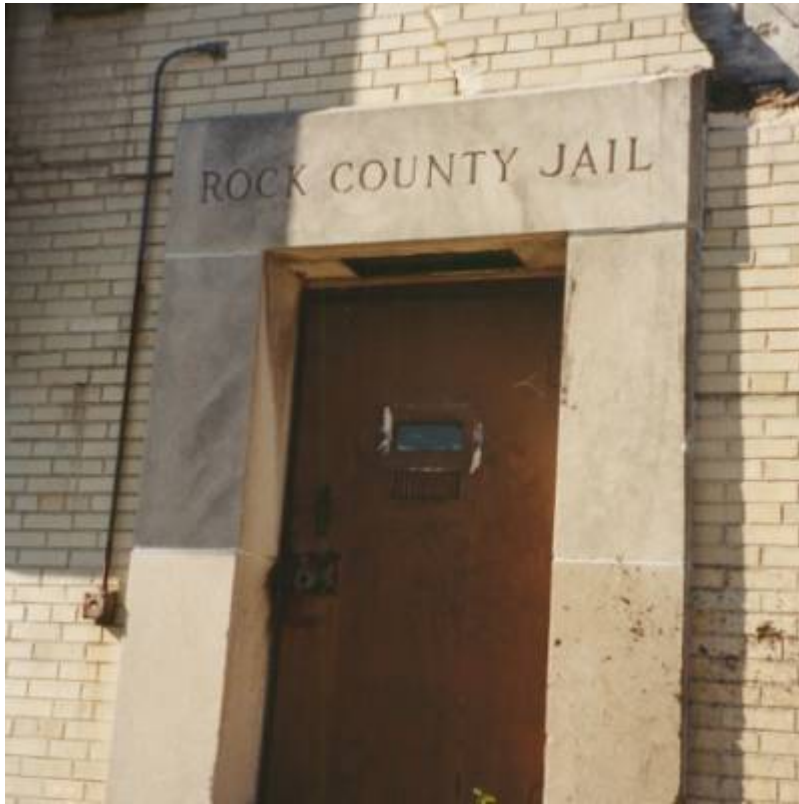
Fig. 1. Water Street.

The proposed renovation of this former jail, built in 1949, posed a number of unique challenges. One challenge was to come up with a new lateral support system that would work with the architect's new cladding system. This concrete framed building was laterally supported by an infill masonry wall system. The removal of this deteriorated wall system required a replacement lateral system. A concrete shear wall system integrated with the existing concrete frame was selected. An interesting aspect of the design of this shear wall system was modeling the system so as to not axially load the new walls with existing loads yet deliver the required shear loads thru the diaphragm to the shear walls (Figures 8-11). Another challenge was to evaluate the load-carrying capacity of the existing concrete floor system due to a change in use. Fortunately existing structural plans were available which made the evaluation process considerably easier. This is not always the case when renovating an existing building.
